Water Chemism Within the Settling Pond of Valea Straja and the Quality of the Suha Water Body (Eastern Carpathians)

GHEORGHE ROMANESCU¹, ALINA TIRNOVAN^{1,2}, ION SANDU^{3*}, GIANINA MARIA COJOC^{1,2}, IULIANA GABRIELA BREABAN¹, ALIN MIHU-PINTILIE¹

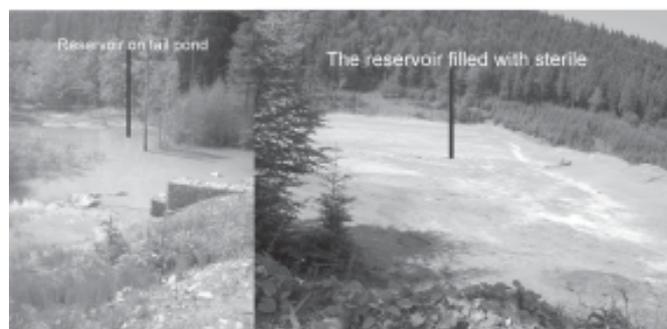
Fig. 2 Accumulation of water and tailings in the settling pond of Valea Straja

The settling pond of Valea Straja is part of the Lesu Ursului-U.P. Tarnita mining complex and it was built for depositing the tailings resulted from the technological process and for the mechanical treatment of wastewater resulted from depositing the tailings and mine waters. The settling pond of Valea Straja is included in the category of valley settling ponds with dam in the back (it blocks a valley using two dams: one downstream from the settling pond, with foundation consolidated with coarse local material and the rest made of tailings; the second dam is made of local material and it helps diverting the stream and orienting the water from precipitations toward the lack situated at the end of the pond). The settling pond of Valea Straja contains the following: the 24 m-high dam downstream from the settling pond, with a priming role; the dam upstream from the pond; the support dam upstream from the priming dam, which delimits the lack at the end of the pond; the diverting dam (in the back), which changes the direction of the Straja stream; the reservoir, situated at the end of the settling pond; the dam that deviated the Valea Straja stream (fig. 2).

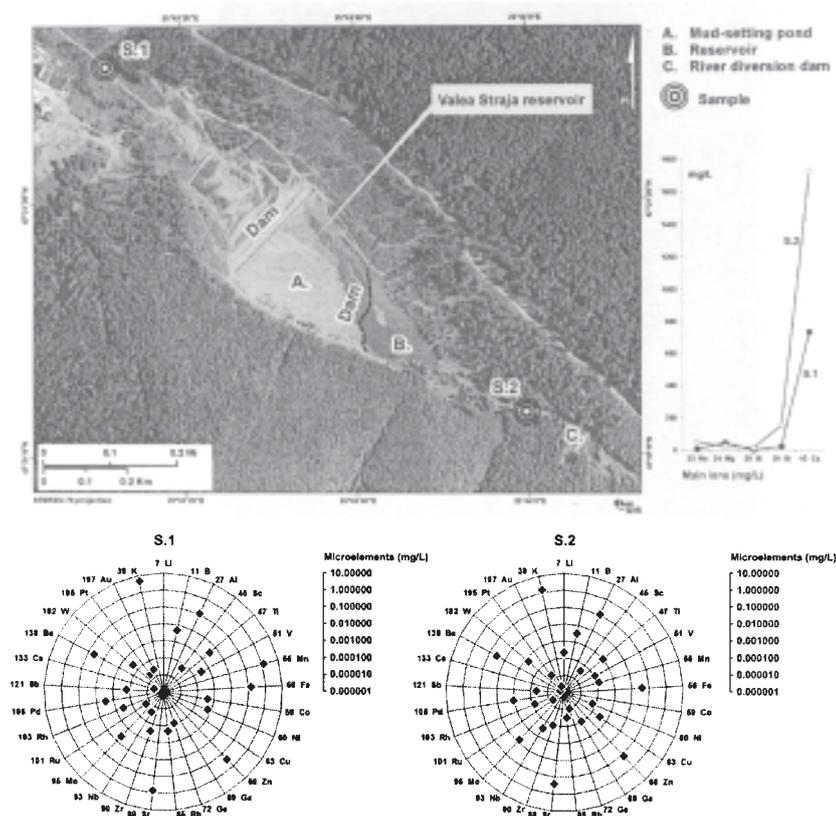
Fig. 3 The chemical parameters of water upstream and downstream from the Valea Straja reservoir

Results of analyses show that, from a qualitative perspective, the water samples from the Straja creek, upstream from the settling pond (S.2), range within normal chemical parameters. In this case, the concentrations of sulphates, residuals, Cu, Pb, Fe, Mn, Cd do not exceed the limits imposed by STAS [Romanian State Standards]. The output water in the inverse probe includes Zn ions that exceed legal limits by 39%; Mn ions exceed the legal limit

7.35 times; sulphates exceed it by 21%, while fixed residual exceeds accepted limits by 100%. The input water in the inverse probe includes Cu ions and Zn ions that exceed the legal limits by 22% and 118%. The values recorded downstream (S.1) are almost identical to those recorded upstream (S.2) (fig. 3).

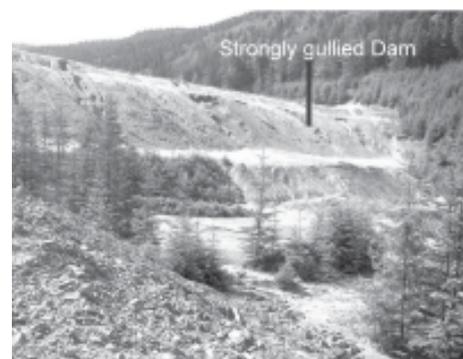
Fig. 4 Significantly gullied dam located downstream from the settling pond of Valea Straja

The vulnerable points of the settling pond are the following: the grids of inverse probes; the under-crossing gallery that takes over the precipitation water through inverse probes; the rings and spillways that direct the water running off from slopes to the back of the settling pond are filed with alluvia and floating matters (in fact, water is taken over by the same under-crossing gallery); the potential breaking of the dam located downstream from the settling pond, already severely fissured (fig. 4).

The dam of the settling pond is highly prone to breaking because floods are frequent in the Suha catchment; their intensity has increased significantly in the past few years. The risk is high because natural conditions are favourable to floods: extended surface of the hydrographical basin upstream from the settling pond; existence of seven torrents on the right side of the settling pond; slopes with big inclination (20-45°); weak forestation; the texture of the soil, full of diluvium, hence with low storage capacity; very deep gullying of the settling pond dam, which makes the pond highly prone to clogging, etc.

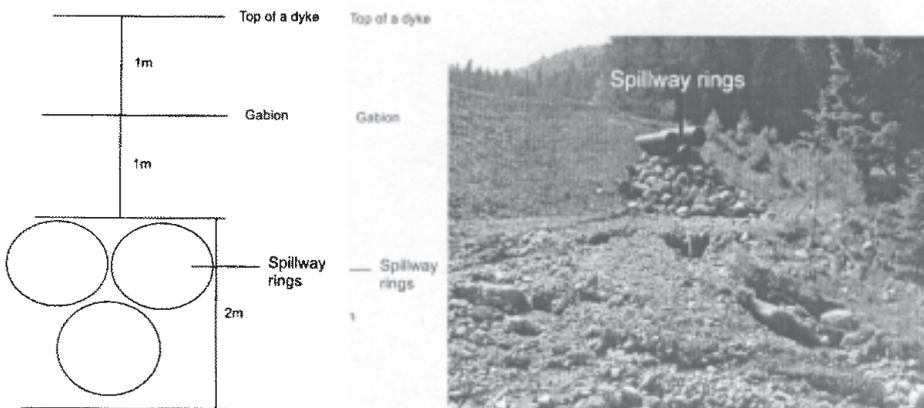
Fig. 5 Position of spillway rings
within the settling pond of Valea
Straja

For determining the discharges by various insurances, we set a three-hour period as average for high water raise, 12 hours for total high water period and a 0.26 coefficient of high water form. The mathematical calculations resulted in the following values: for 1% insurance – maximum discharge of 27.5 m^3/s ; for 2% insurance – maximum discharge of 20.0 m^3/s ; for 5% insurance – maximum calculated discharge of 12.4 m^3/s ; while for 10% insurance – maximum discharge of 7.66 m^3/s . After determining these values, possible Q max to evacuate through the three spillway tubes (800 mm in diameter) within the deviation dam was calculated (fig. 5).

If water level reaches the gabion, the evacuated discharge is 7.30 m^3/s ; if it reaches the cornice of the dam, the discharge increases to 9.20 m^3/s . The hydraulic calculation proves that tubes can take over only up to 9.81 m^3/s . Discharges exceeding this value cannot be evacuated through the spillways, case in which the water would exceed the cornice of the dam (fig. 6). The friable material of the dam would be eroded soon, and water filled with pollutants would penetrate river streams. In order to pinpoint the risks, it is necessary to make a correlation between recorded discharges and amount of precipitations [33].
