# The Involvement of Bacteria in the Failure of a Carbon Steel Pipe

This paper presents a study regarding the implication of bacteria in the degradation of a pipe from a raw water cooling system.

In our work was investigated an OLT35 carbon steel pipe part. The pipe had a 6" internal diameter.

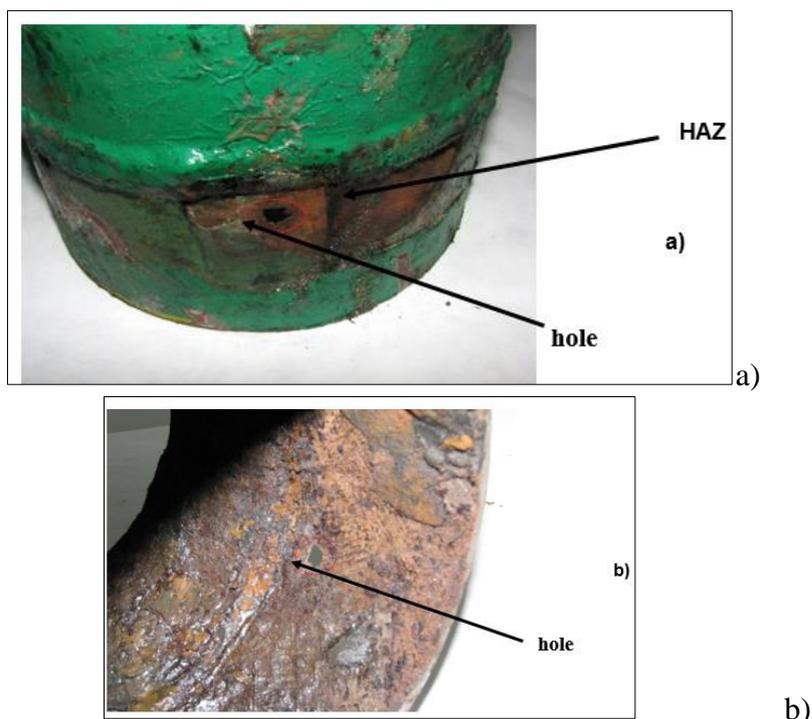
On the outside (Figure 1a), the corrosion protection of the pipe was made by coating, but there are some areas where the paint was exfoliated. However, the pitting corrosion was initiated from inside of the pipe (Figure 1b), because in the inner the pipe was completely covered by uneven and bulky deposits, adhering to its surface. The structure of the deposit is specific to the mode in which the microorganisms form their biofilms on metal surfaces. On the welding joint, in the heat-affected zone (HAZ), the pitting corrosion led in time to its perforation - hole size - about -10mm.

**Figure 1.**  
Aspect of failure pipe.  
*a) outside of pipe,*  
*b) inside of pipe*

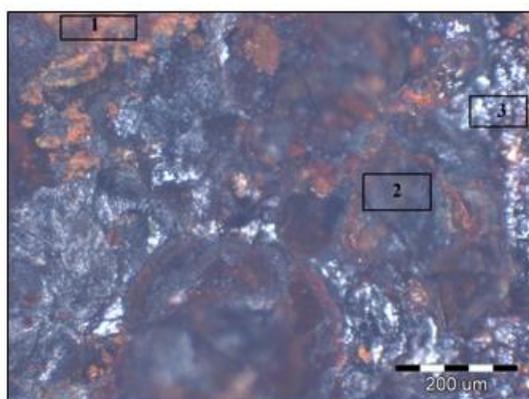
Metallographic analysis [7] of some pipe areas obtained at a magnification of 100 times (Figure 3), emphasized the deposits of corrosion products with different colors, such as, red-brown as a result of heterotrofe aerobe and iron –oxidizing bacteria (zone 1) and black-as a result of sulphate-reducing bacteria (zone 2).

Also, uncovered areas of pipe (such as zone 3) are observed, because microorganisms do not develop uniform biofilms on metal surfaces.

**Figure 3.** Surface morphology of a pipe sample

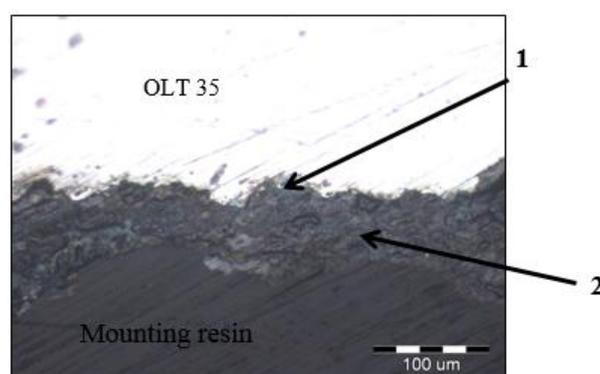
By analyzing the cross-section (Figure 4) were observed the non-uniform corrosion of the steel (zone 1) and the bulky deposition with different thicknesses (34-151 μm) in zone 2.

**Figure 4.** Microscopic examination of the cross-section of the pipe sample [x100]

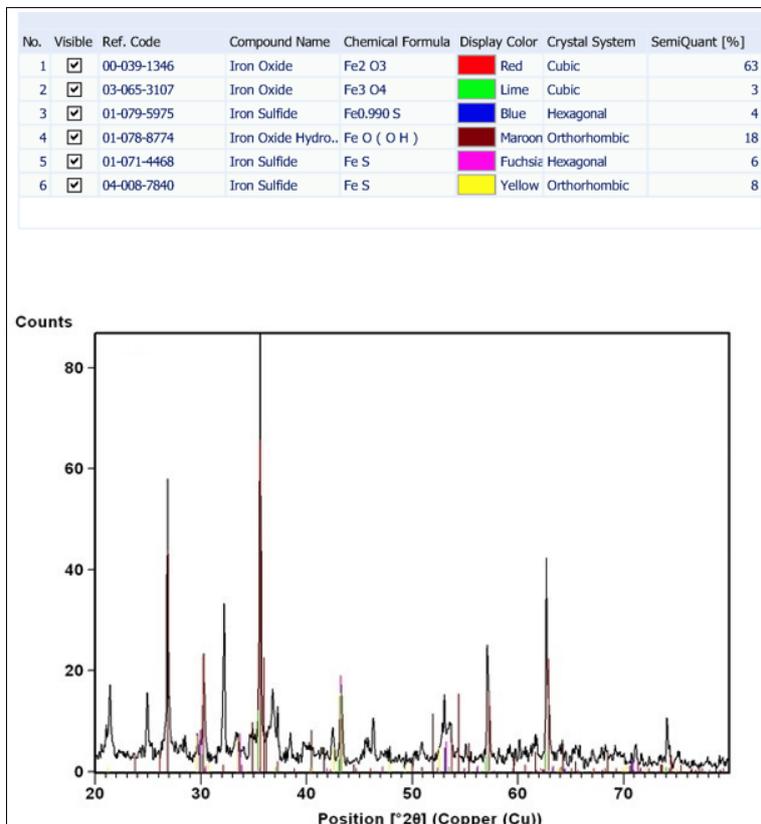
X-ray diffraction analysis of the corrosion products emphasized in zone 1 (Figure 5) the following compounds:  $\text{Fe}_2\text{O}_3$  - 63%,  $\text{FeO}(\text{OH})$  -18%,  $\text{FeS}$ -18%,  $\text{Fe}_3\text{O}_4$ -10% .

**Figure 5.** X-ray diffraction analysis of a sample from pipe-zone 1

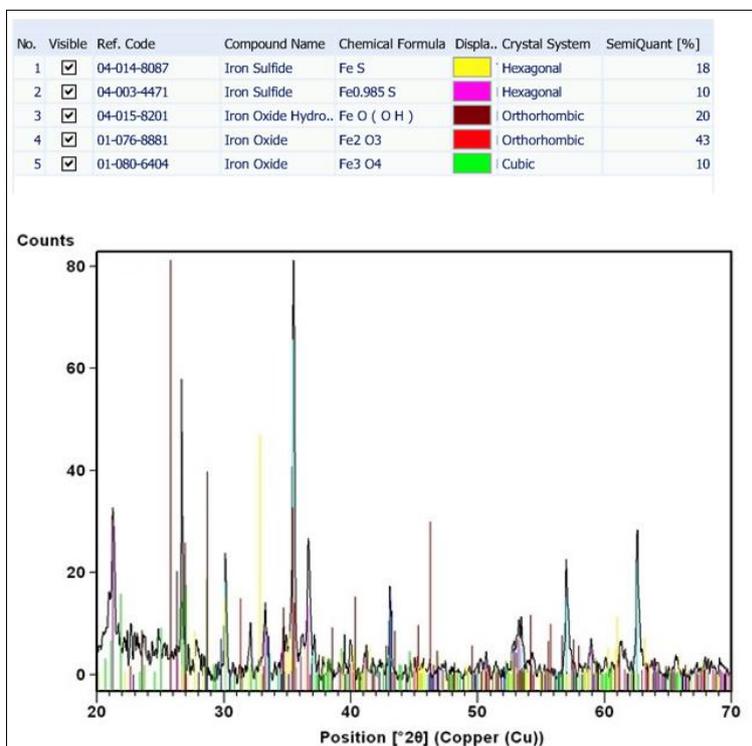
In zone 2 (Figure 6) the corrosion products were: Fe<sub>2</sub>O<sub>3</sub> -43%, FeS -28%, FeO(OH) -20% and Fe<sub>3</sub>O<sub>4</sub> -10%.

**Figure 6.** X-ray diffraction analysis of a sample from pipe-zone 2
