# The Involvement of Bacteria in the Failure of a Carbon Steel Pipe

This paper presents a study regarding the implication of bacteria in the degradation of a pipe from a raw water cooling system.

In our work was investigated an OLT35 carbon steel pipe part. The pipe had a 6" internal diameter.

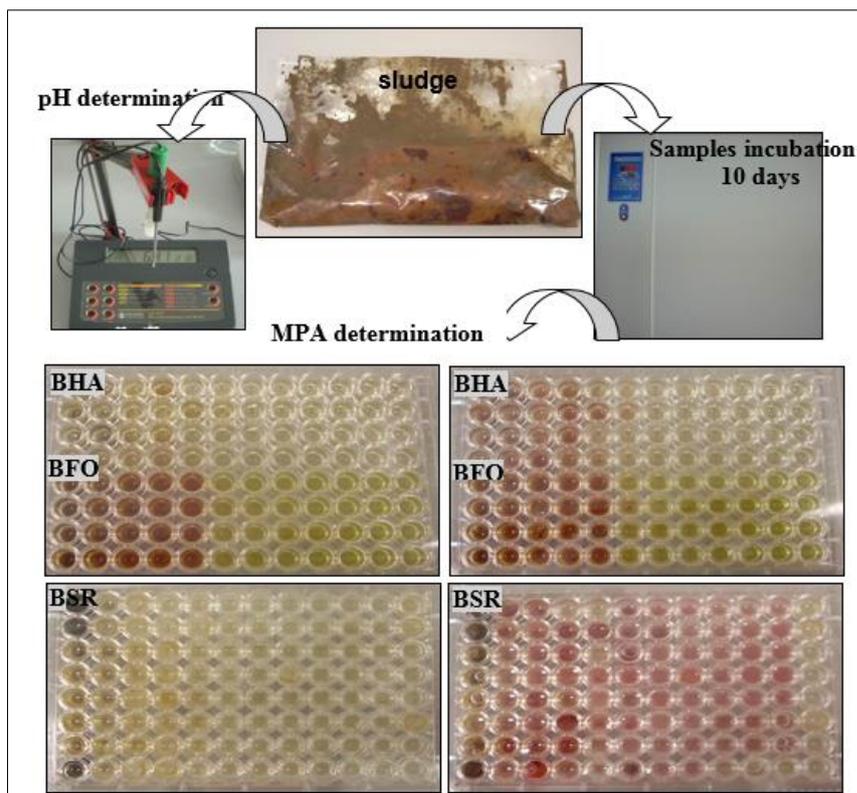
**Figure 2.** The steps of microbiological analyses of sampled sludge  
MPN = Most Probable Number; BHA- heterotrofe aerobic bacteria; BSR- sulphate-reducing bacteria; BFO- iron –oxidizing bacteria

Microbiological analyses of sampled sludge from internal surface of pipe emphasized the existence of some microorganisms: heterotrophic aerobe bacteria, bacteria iron oxidizing bacteria and sulfate-reducing bacteria.

After 10 days of plate incubation at 30°C, the presence of the following groups of bacteria was found: sulfate-reducing bacteria ( $2.5 \times 10^{10}$  UFC/ml), iron oxidizing bacteria ( $2.5 \times 10^4$  UFC/mL) and heterotrophic aerobic bacteria ( $9.5 \times 10^3$  UFC/mL) (Table 1).

The higher number of sulphate-reducing bacteria in comparison to the number of iron-oxidative bacteria and aerobic heterotrophs is explainable, because sludge often creates anaerobe conditions that favor the development of bacteria capable of growing and multiplying in the absence of oxygen.
